# **Debris/Ice/TPS Assessment and Integrated Photographic Analysis of Shuttle Mission STS-73**

*Gregory N. Katnik, Barry C. Bowen, Jill D. Lin,  
Vehicle Engineering/Mechanical System Division/ET-SRB Branch,  
Kennedy Space Center, Florida*

**20 October 1995**

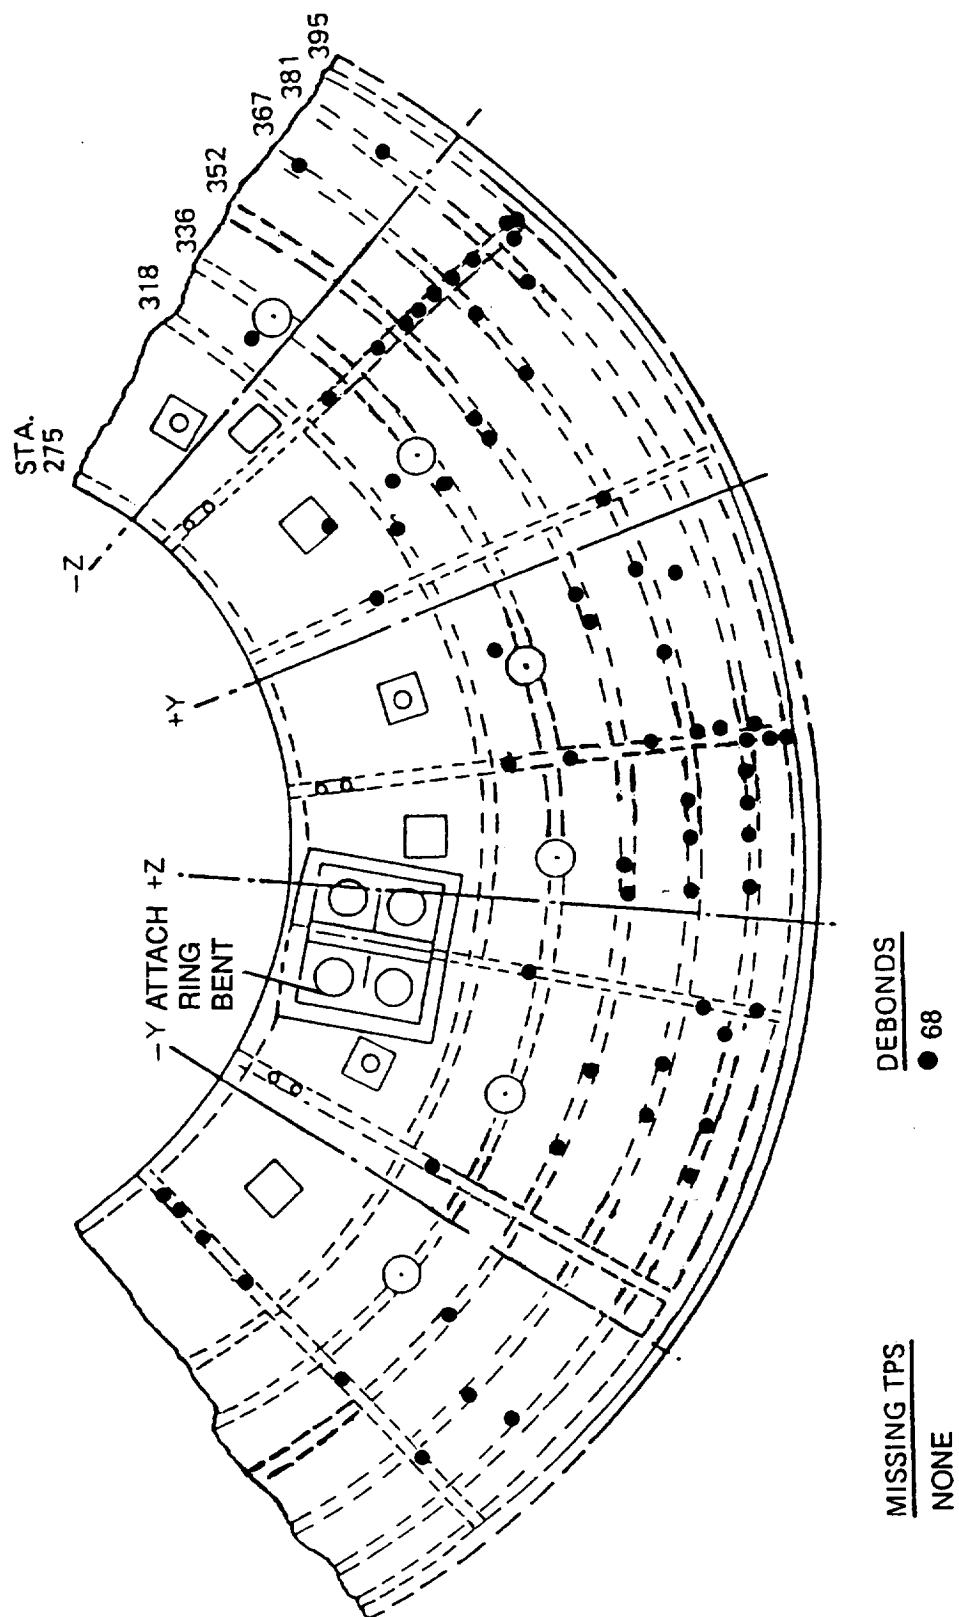
**Figure 1 : RH SRB Frustum**

The RH frustum was missing no TPS. The number of debonds (67) over fasteners was greater than average (Figure 1). Hypalon paint was blistered/missing along the XB-395 ring frame where BTA closeouts had been applied. However, most of the exposed BTA substrate was not sooted. The BSM aero heat shield covers had locked in the fully opened position though the upper left cover attach ring had been bent by parachute riser entanglement.

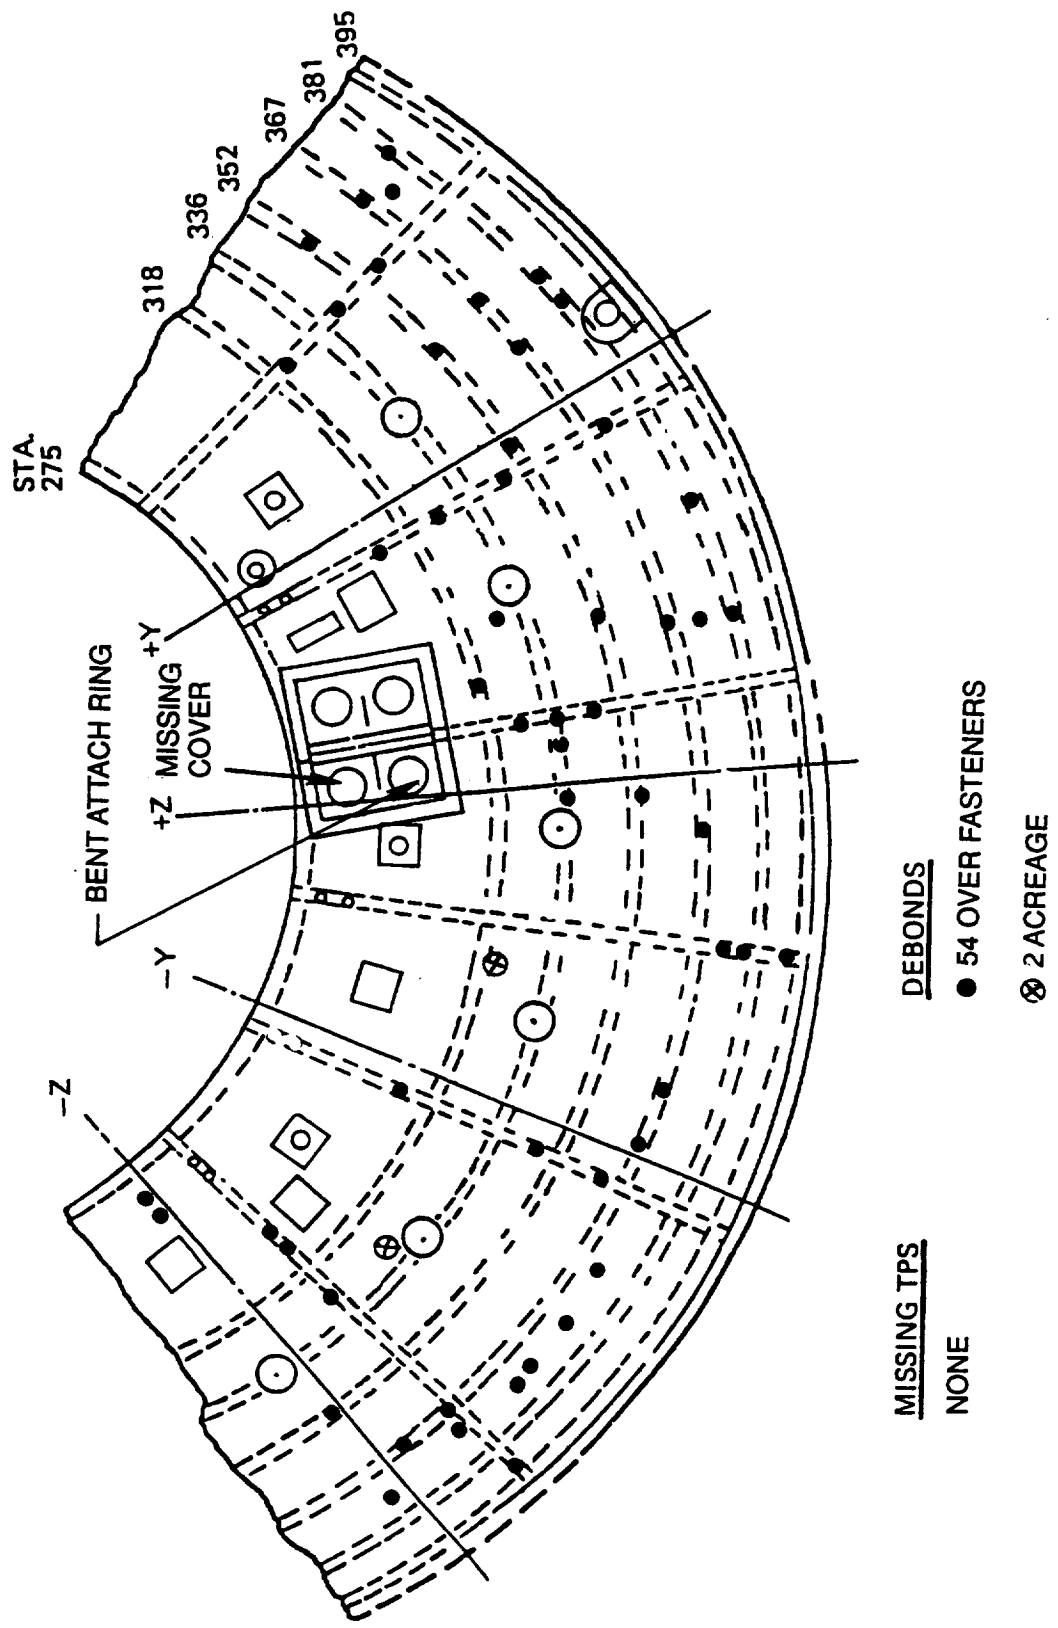
**Figure 2 : LH SRB Frustum**

The LH frustum was missing no TPS. The number of MSA-2 debonds over fasteners (54) and over acreage (2) was greater than average (Figure 2). Hypalon paint was blistered/missing along the XB-395 ring frame where BTA closeouts had been applied. However, most of the exposed BTA substrate was not sooted. The BSM aero heat shield covers had locked in the fully opened position though the lower left cover attach ring had been bent. The upper left cover was missing. The damage to the BSM covers/attach rings was caused by parachute riser entanglement after splashdown.

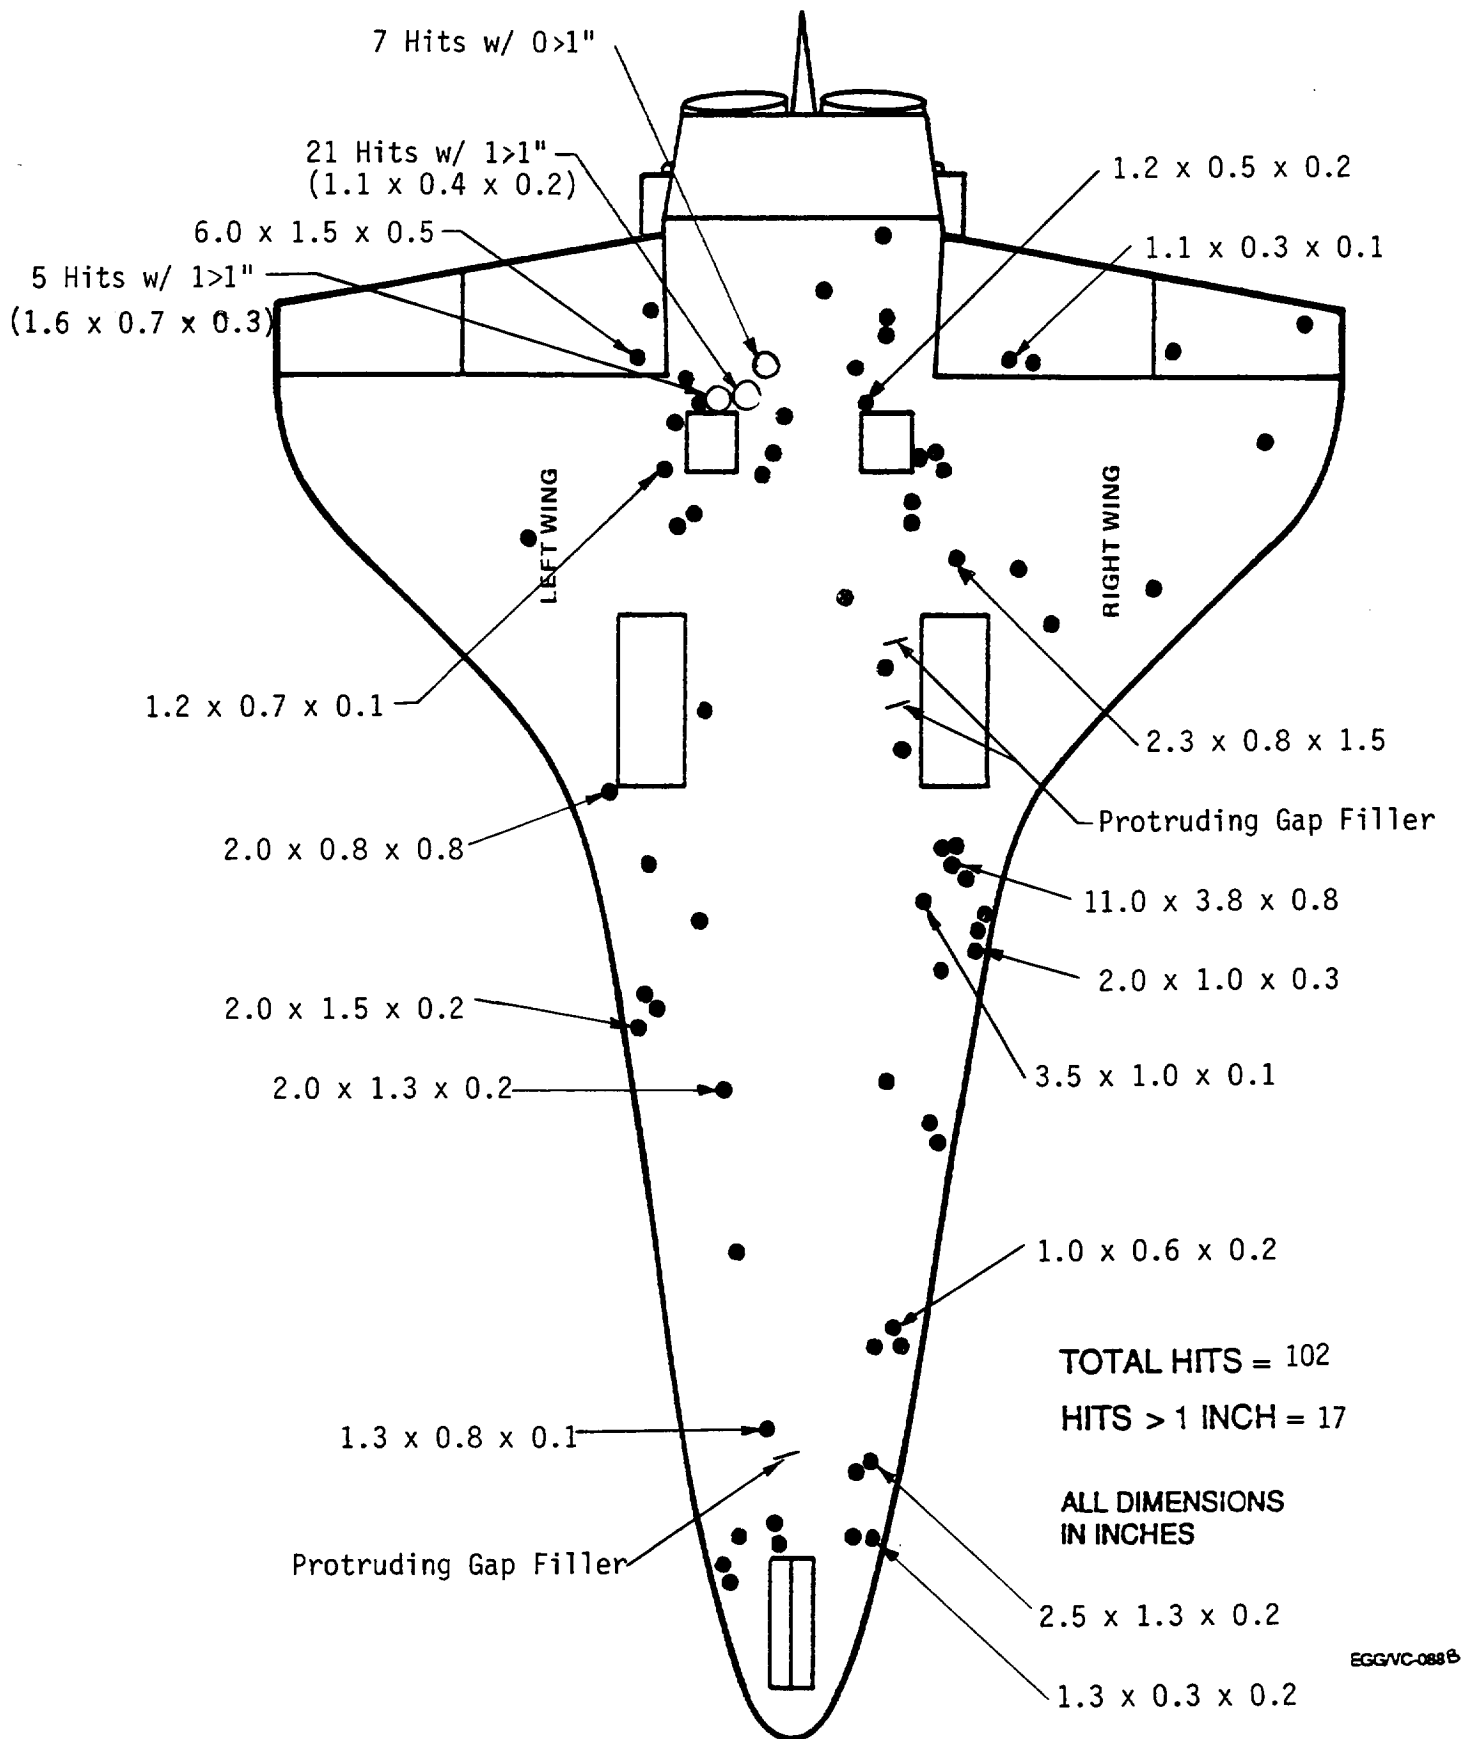
**Figure 3 : Orbiter Lower Surface Debris Map**

In summary, both the total number of Orbiter TPS debris hits and the number of hits 1-inch or larger was greater than average when compared to previous missions (Figure 7).

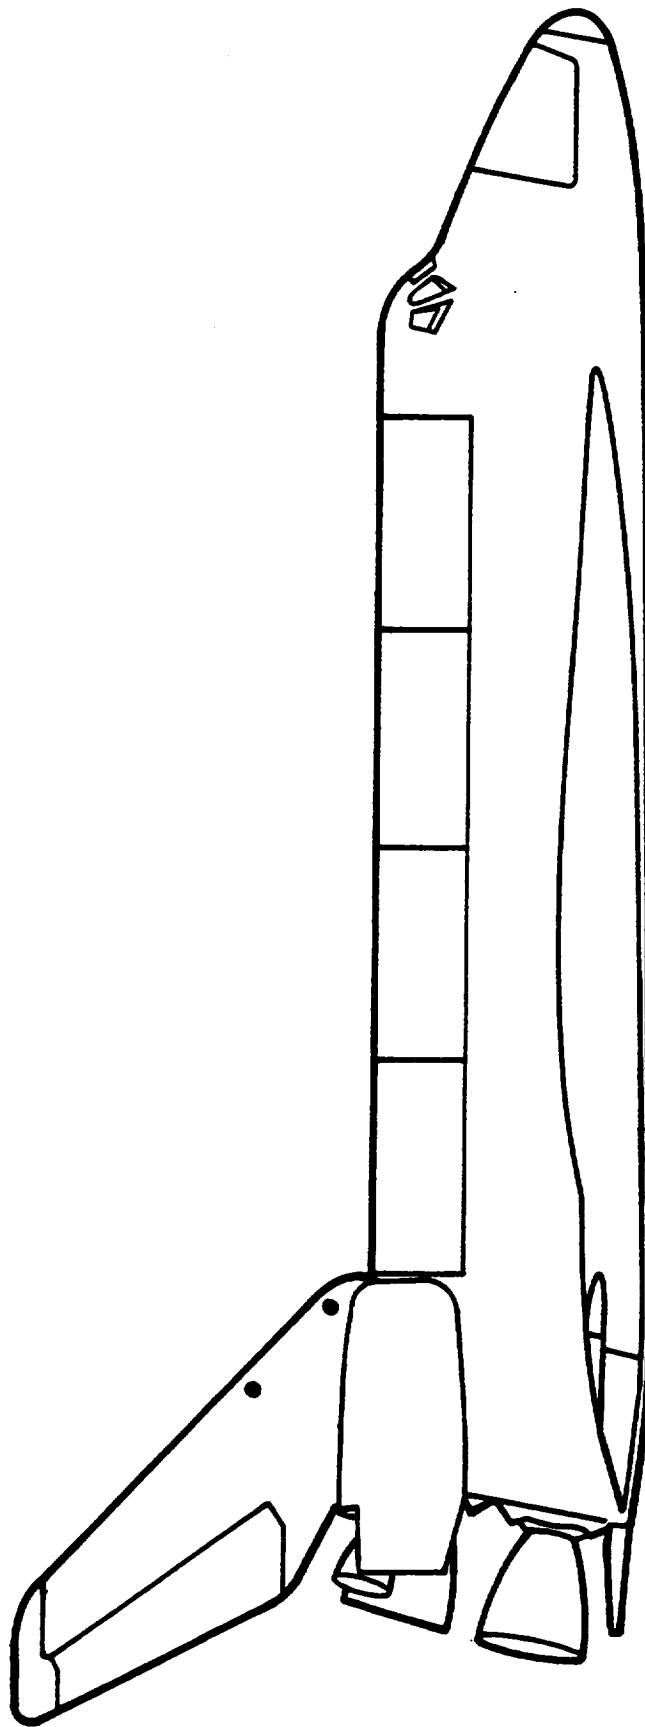
**Figure 4 : Orbiter Right Side Debris Map**

TOTAL HITS = 2  
HITS > 1 INCH = 0

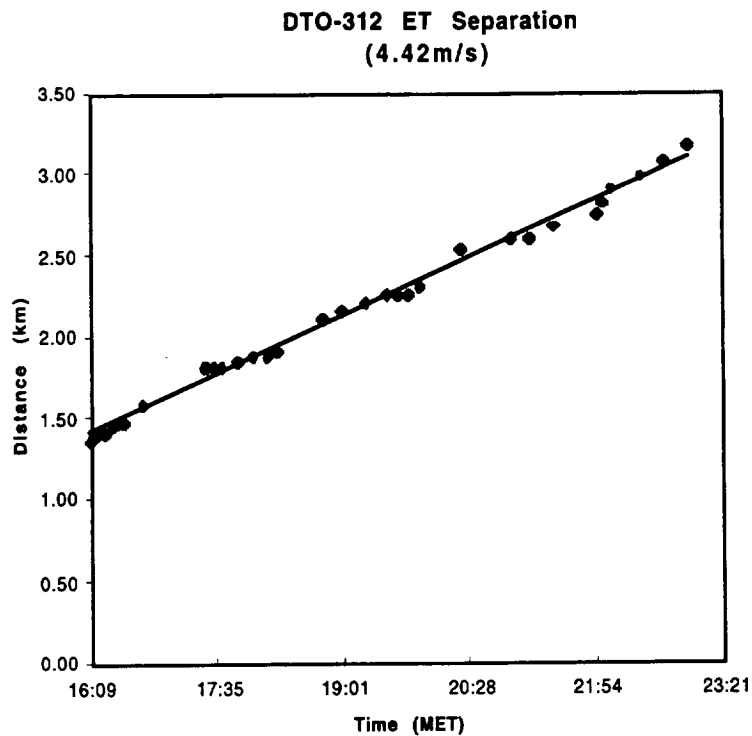
**Figure 2.4.1 (A) ET Separation Velocity**

The external tank was calculated to be a distance of 1.37 kilometers away from the Orbiter on the first image (taken 16 minutes after liftoff). The tank separation velocity was calculated to be 4.42m/s. The roll rate of the external tank was calculated to be 0.15 deg/sec. The tumble rate was calculated to be 1.91 deg/sec.

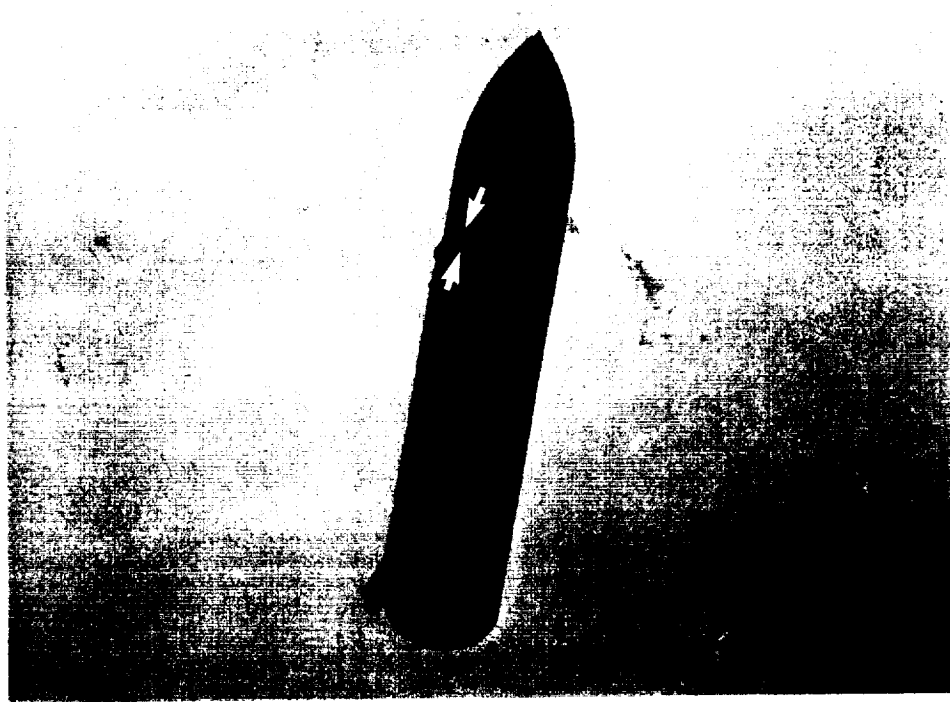
**Figure 2.4.1 (B)** Light Colored Marks on the +Y Axis of ET Intertank

Light colored marks were noted on the +Y axis of the Intertank in the BSM burn scar near the RSRB/ET forward attach point. Similar marks were seen near the LSRB/ET forward attach on the STS-57 handheld ET photography.

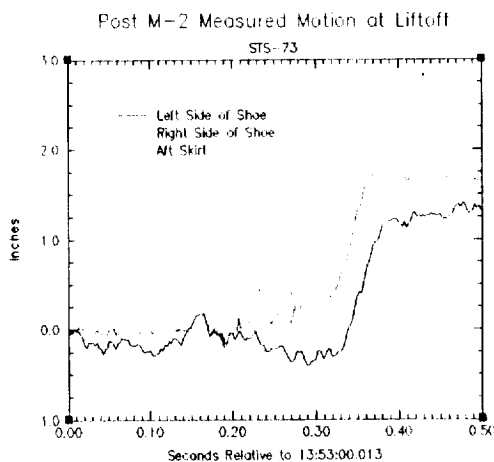
Figure 1. Measured Motion Data

The holddown post M-2 stud hung-up in the aft skirt at liftoff. Measured motion data of the post components are shown in figure 1. Figure 2 is a film frame from camera E-8 showing the stud hang up and the location of the measured components. The holddown post shoe was lifted up approximately 2 inches during liftoff. The stud appeared to remain fully extended until the aft skirt cleared the top of the stud.
